1. REPORT NO. FHWA/CA/TL-80/23		2. GOVERNMENT ACCESSION NO.		3. RECIPIENT'S CATALOG NO.	
4. TITLE AND SUBTITLE MODEL SLAB FAULTING STUDY				5. REPORT DATE June 1980

STATE OF CALIFORNIA
DEPARTMENT OF TRANSPORTATION
DIVISION OF CONSTRUCTION
OFFICE OF TRANSPORTATION LABORATORY

MODEL SLAB FAULTING STUDY

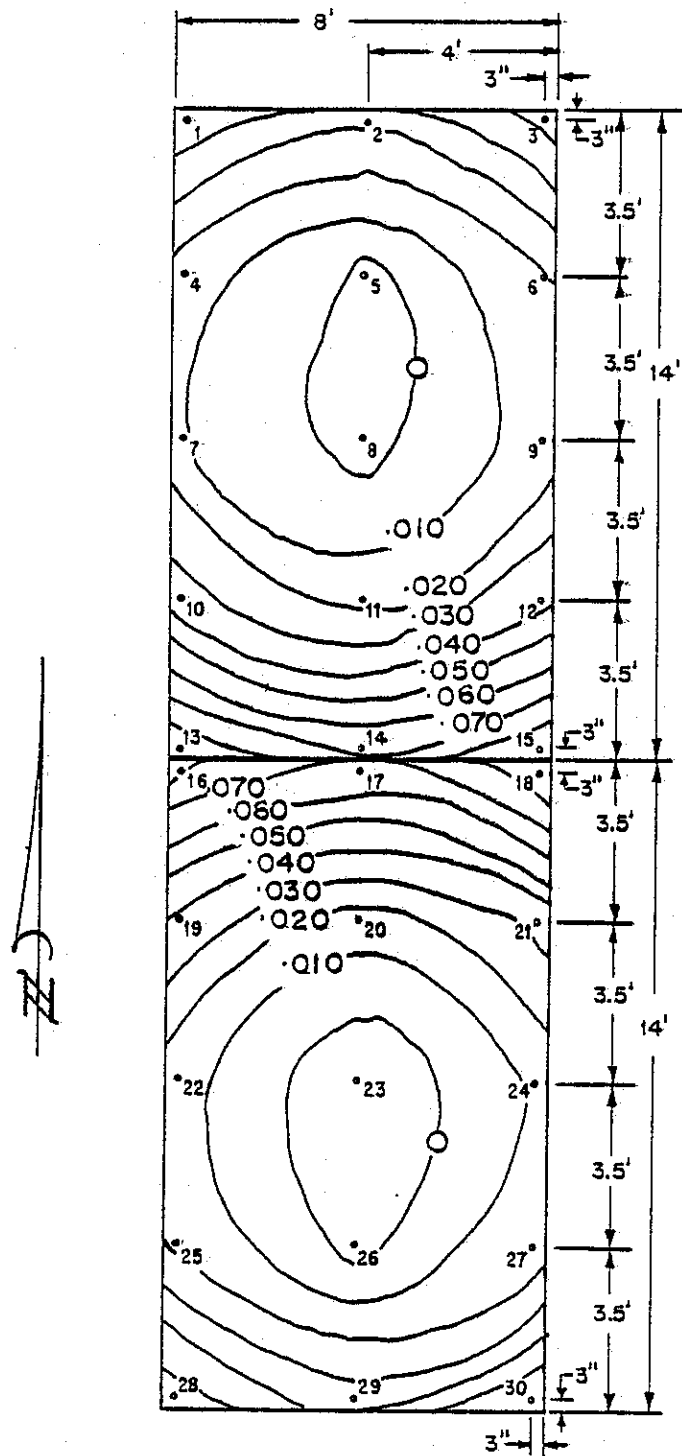
Figure 8

During the approximately 7 month period between completion of the test slab and equipment installation, temperature and curl gages were monitored periodically. The circulating hot water effectively raised the temperature at the bottom of the slab. However, due to the high thermal conductivity of concrete, it also raised the temperature throughout the slab. This reduced the thermal gradient and the amount of induced curl. During the monitoring period, the water temperature was held to about 110°F and slab temperature was not raised above about 90°F. When the water was not circulating, temperatures throughout the structural section were uniform and approximately the same as ambient. As the concrete dried, upward curl increased daily, with a maximum of 0.03 inch after 7 days, 0.05 inch after 14 days, and a peak of about 0.10 inch in 3 months, although total curl varied with changes in temperature. An isogram of the curl after 6 months with uniform temperature of 56°F is shown in Figure 8, at which time maximum curl was about 0.085 inch.

ISOGRAM OF CURL
SIX MONTHS DRYING-NO LOADING

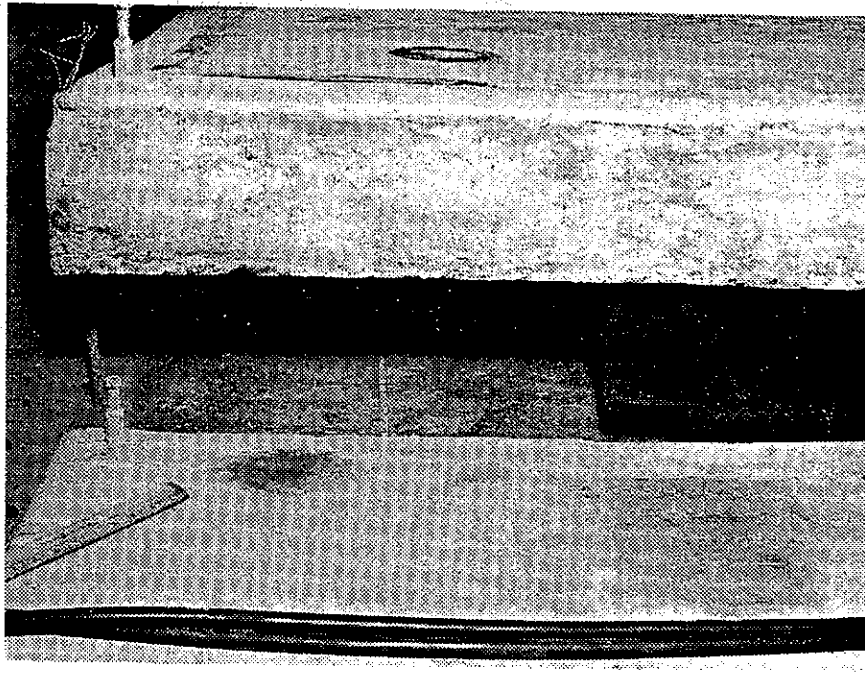
Figures 14-17 show the base surfaces. Some of the coarser aggregate particles (3/8-1/2 in.) shown in Figure 15, probably came from either the bottom of the slab or the top of the CTB, as well as from the shoulder. Since all aggregates used, including the shoulder, were supplied by the same company, the source of coarser particles could not be identified. The small mound seen in the right center of Figure 15 is a buildup under the plug in the core hole. This was a result of failure to screw the plug

Fig. 14
Deposit of aggregate particles
beneath raised approach slab.

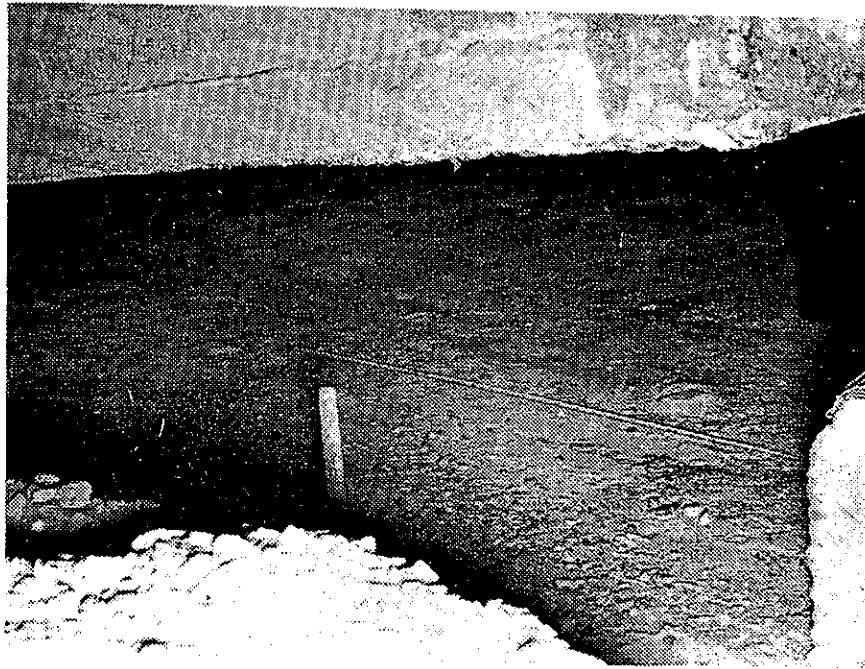
Fig. 15
Looking under approach slab from
"shoulder" area. Showing close-up
of migrated material.

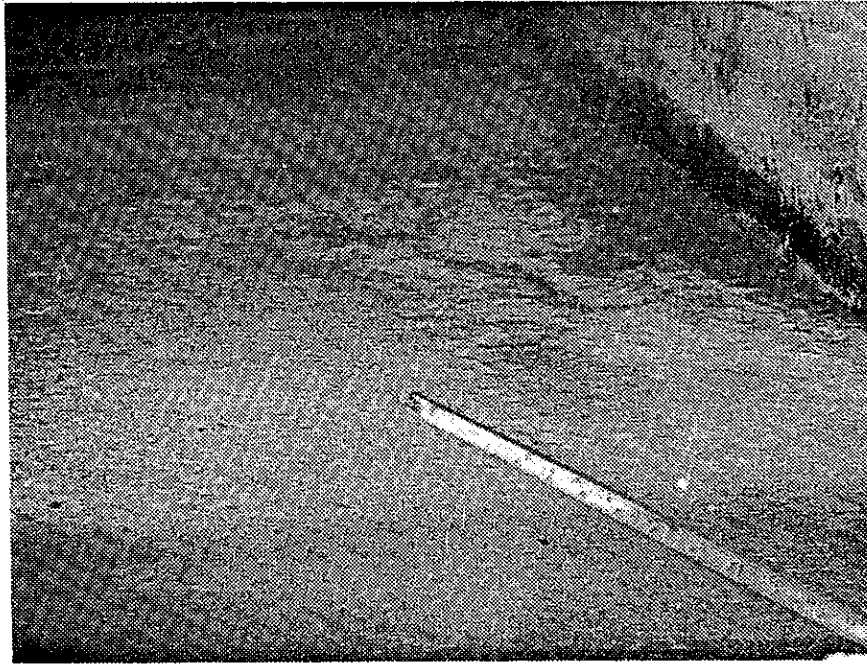
down sufficiently the last time it was removed for observations. Figure 16 shows the buildup under the approach slab on the inner side. The fines extend about 4 ft from the joint at this point and about 5 ft from the outer shoulder. Figure 17 shows the surface near the joint with both slabs raised. Abrasion of the edge of the leave slab (right side) due to pumping of aggregate particles can also be seen.

Fig. 16
Deposit of material along
inside wall of test bed.

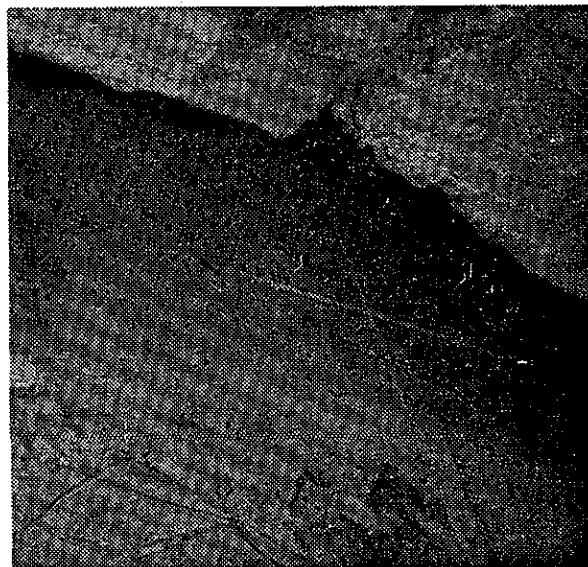
On completion of the above observations, the migrated materials were removed by water and squeegee. The base under the leave slab, for about 16 sq ft near the joint and shoulder, was found to be badly scoured. As much as a half inch of base was removed in numerous spots. This condition was not found under the approach slab. The bottoms of both slabs indicated considerable abrasion, however.

Fig. 17
View under leave slab
with both slabs raised.

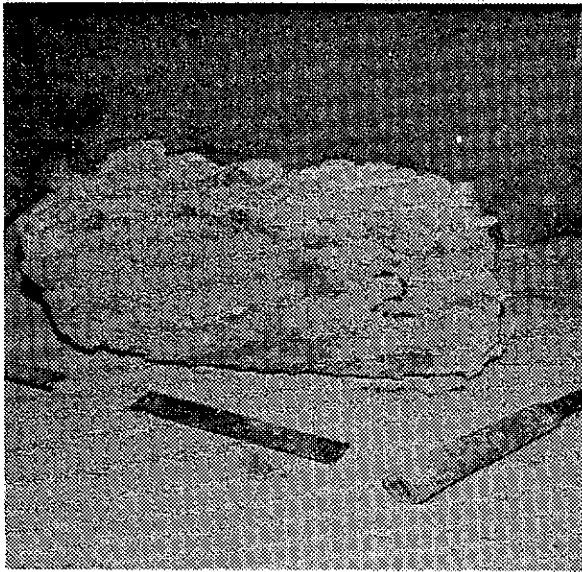
Fig. 18
Porous concrete plugged -
edge adjacent to slab.

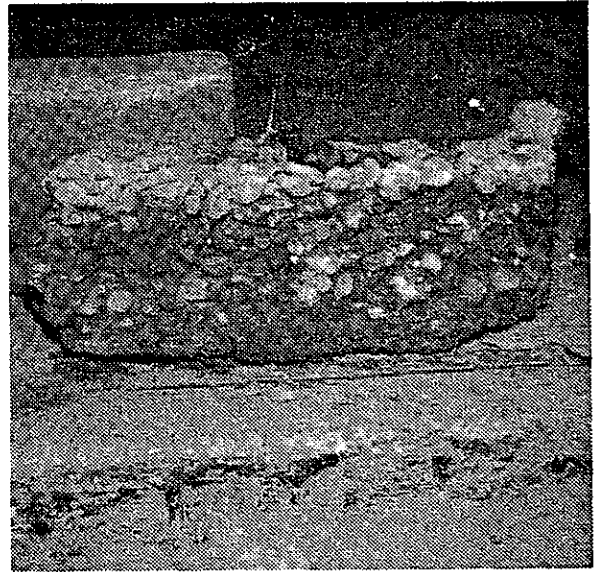
Fig. 19
Porous concrete - edge
away from slab.

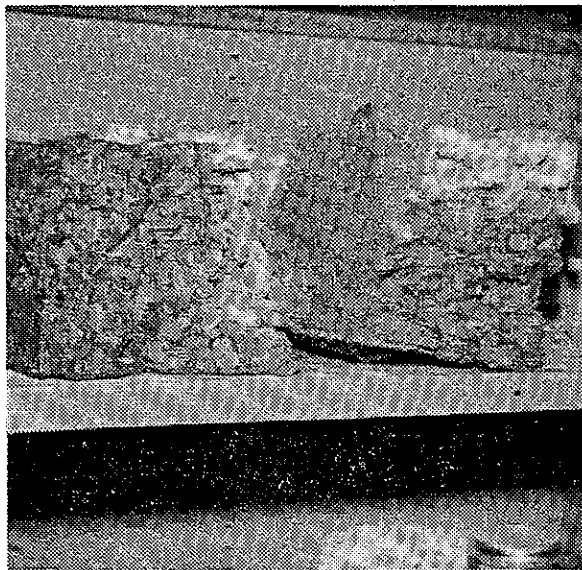
Fig. 20
Broken section of porous
concrete - all voids filled.
